# Texturoptimerade vägbeläggningar

**Av Ulf Sandberg**

**VTI**

TRV Seminarium i Solna 2012-12-12

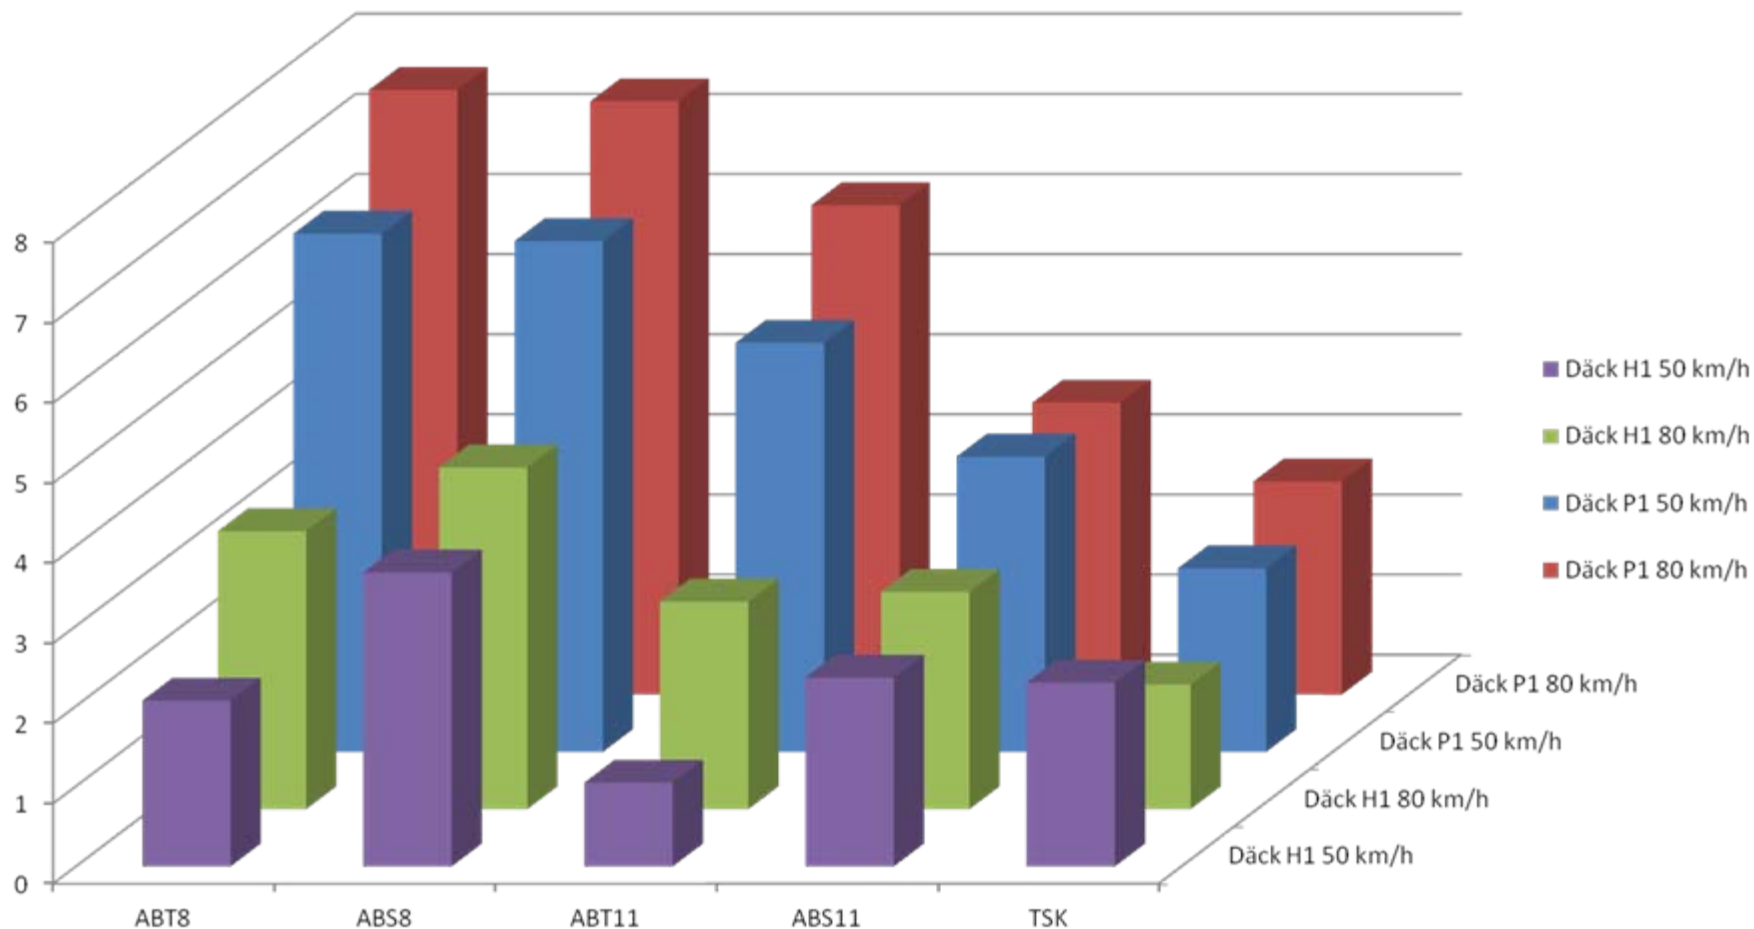
# RV13 Höör & RV11 Tomelilla & E22 Hörby (ref) År 2010 (nylagda)

Bullerreduktion jämfört med ABS 16 på E22 vid Hörby, i A-viktade dB

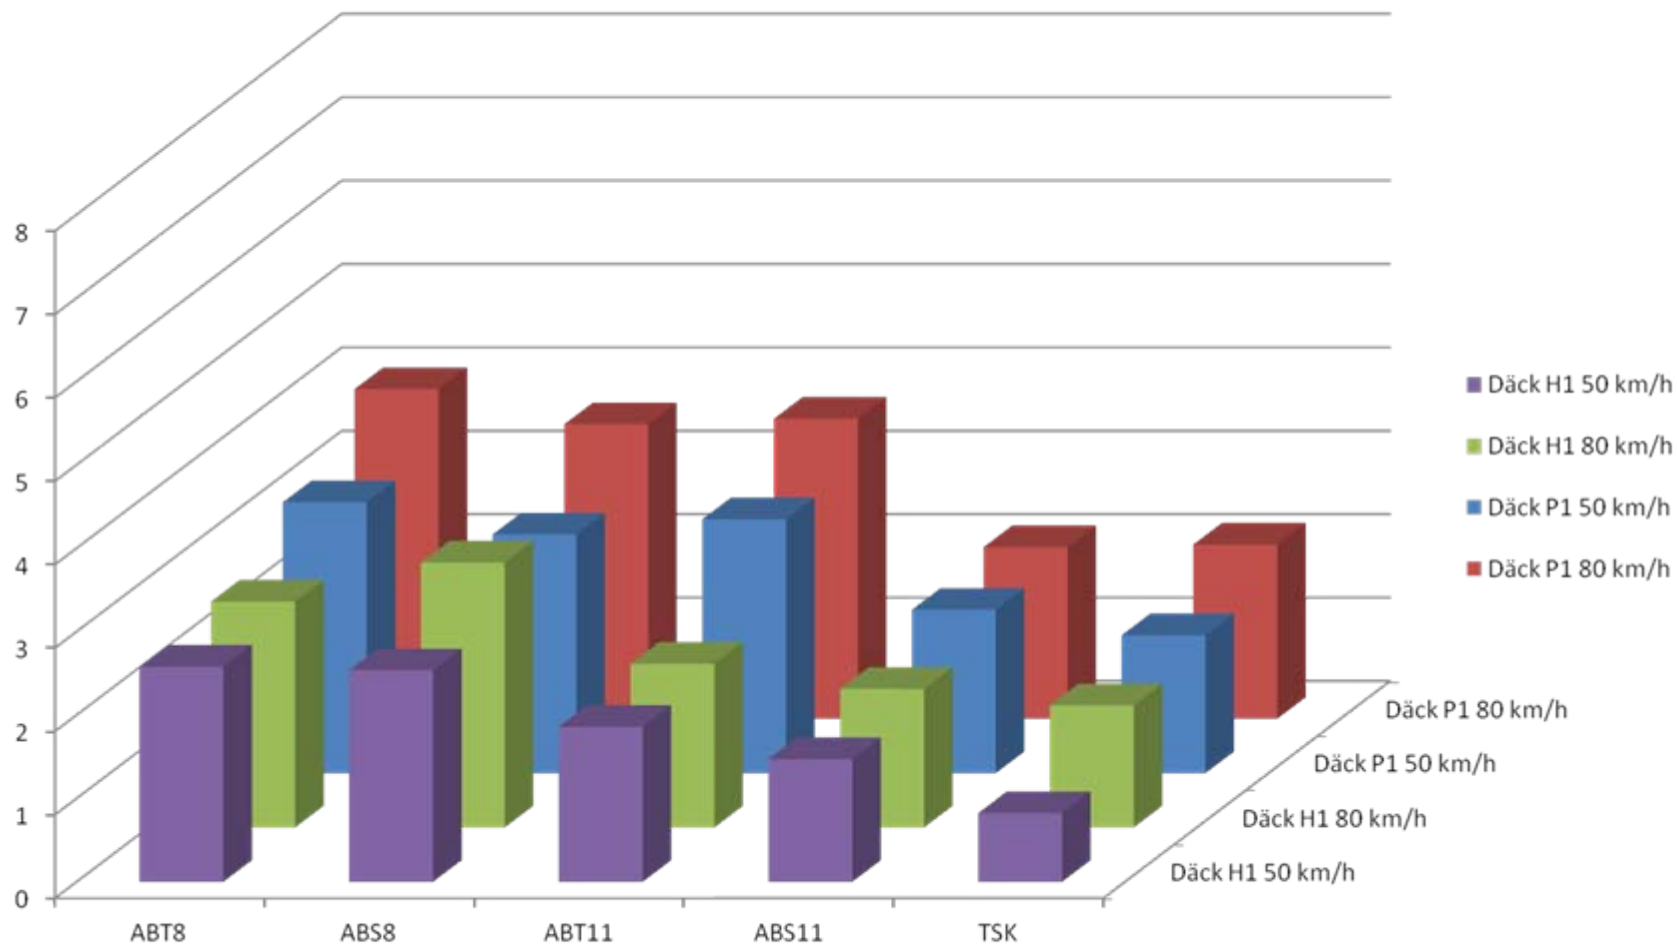
# RV13 Höör & RV11 Tomelilla & E22 Hörby (ref) År 2011 (ett år gamla)

Bullerreduktion jämfört med ABS 16 på E22 vid Hörby, i A-viktade dB

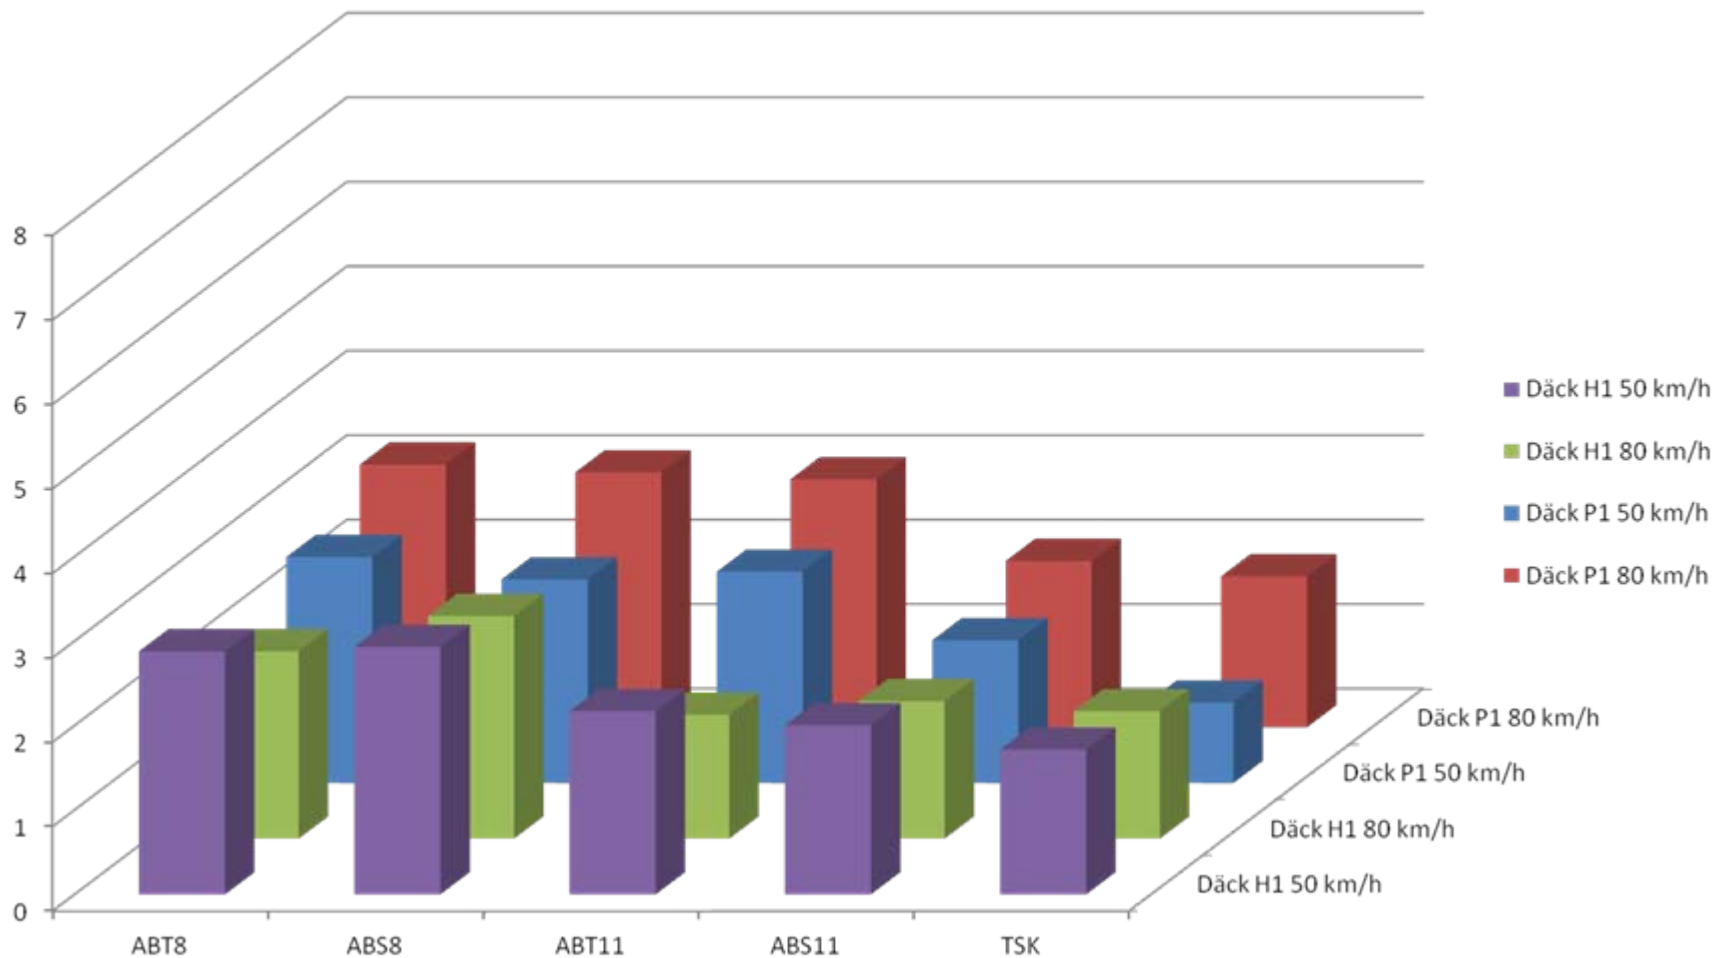
# RV13 Höör & RV11 Tomelilla & E22 Hörby (ref) 2012 (två år gamla)

Bullerreduktion jämfört med ABS 16 på E22 vid Hörby, i A-viktade dB

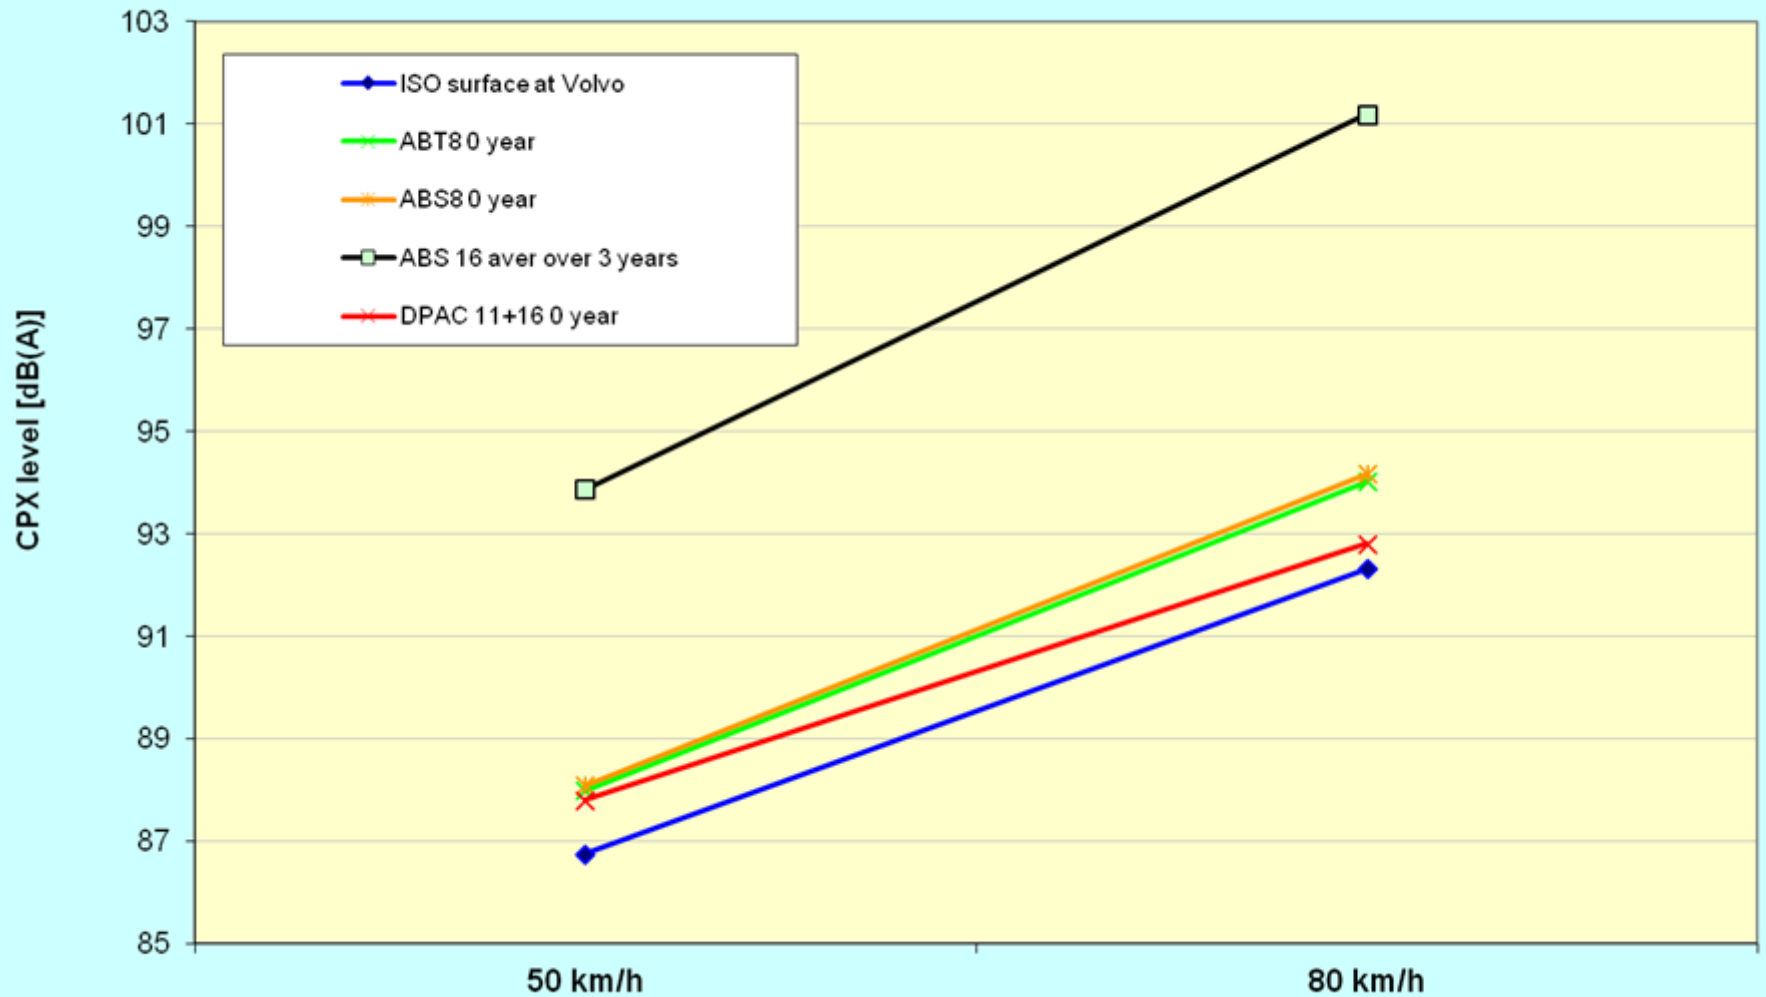
# ISO 10844 surface at Volvo compared to in-service roads

## Tyre P1

Comparison of Volvo ISO track with real road surfaces - SRTT

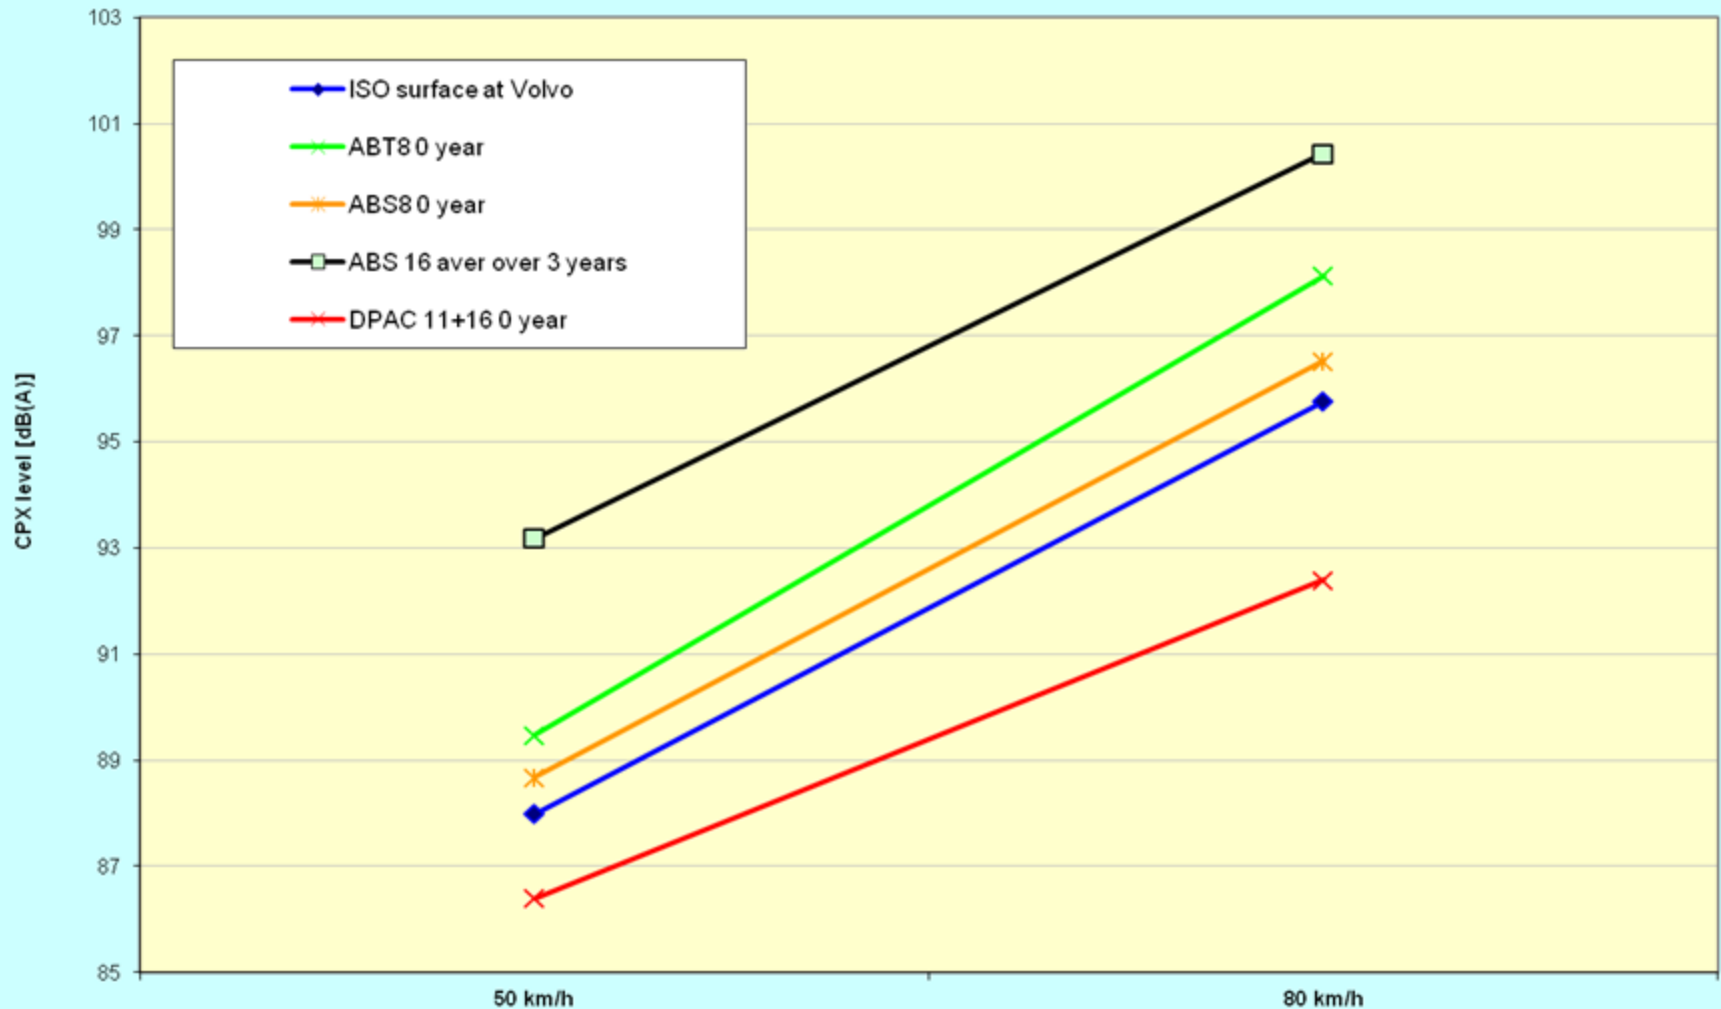
# ISO 10844 surface at Volvo compared to in-service roads

## Tyre H1

Comparison of Volvo ISO track with real road surfaces - AAV4

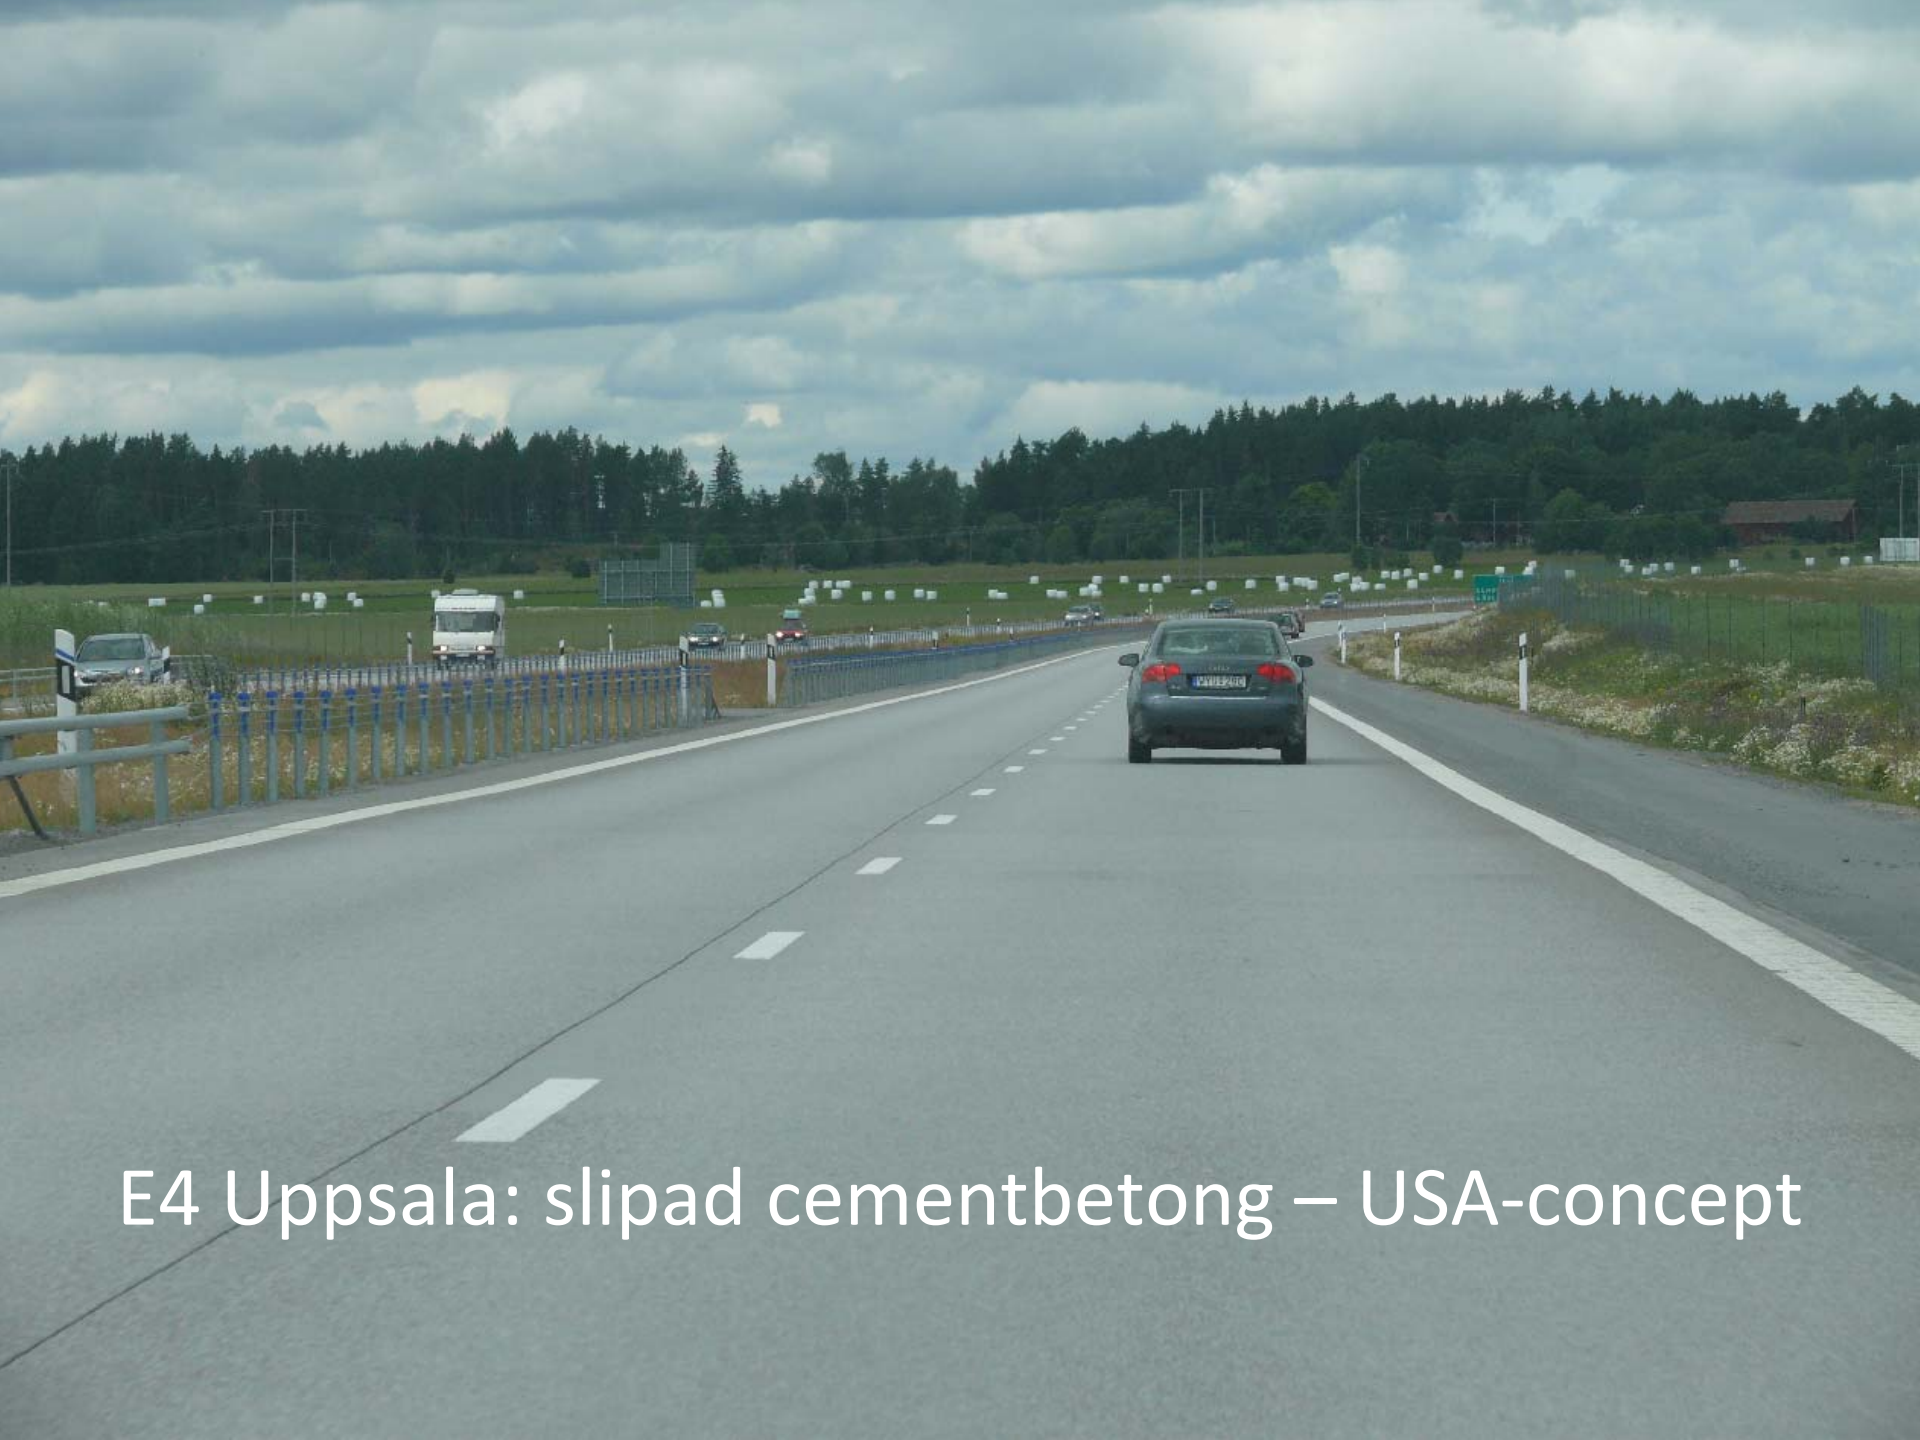
E4 Uppsala: slipad cementbetong – USA-concept

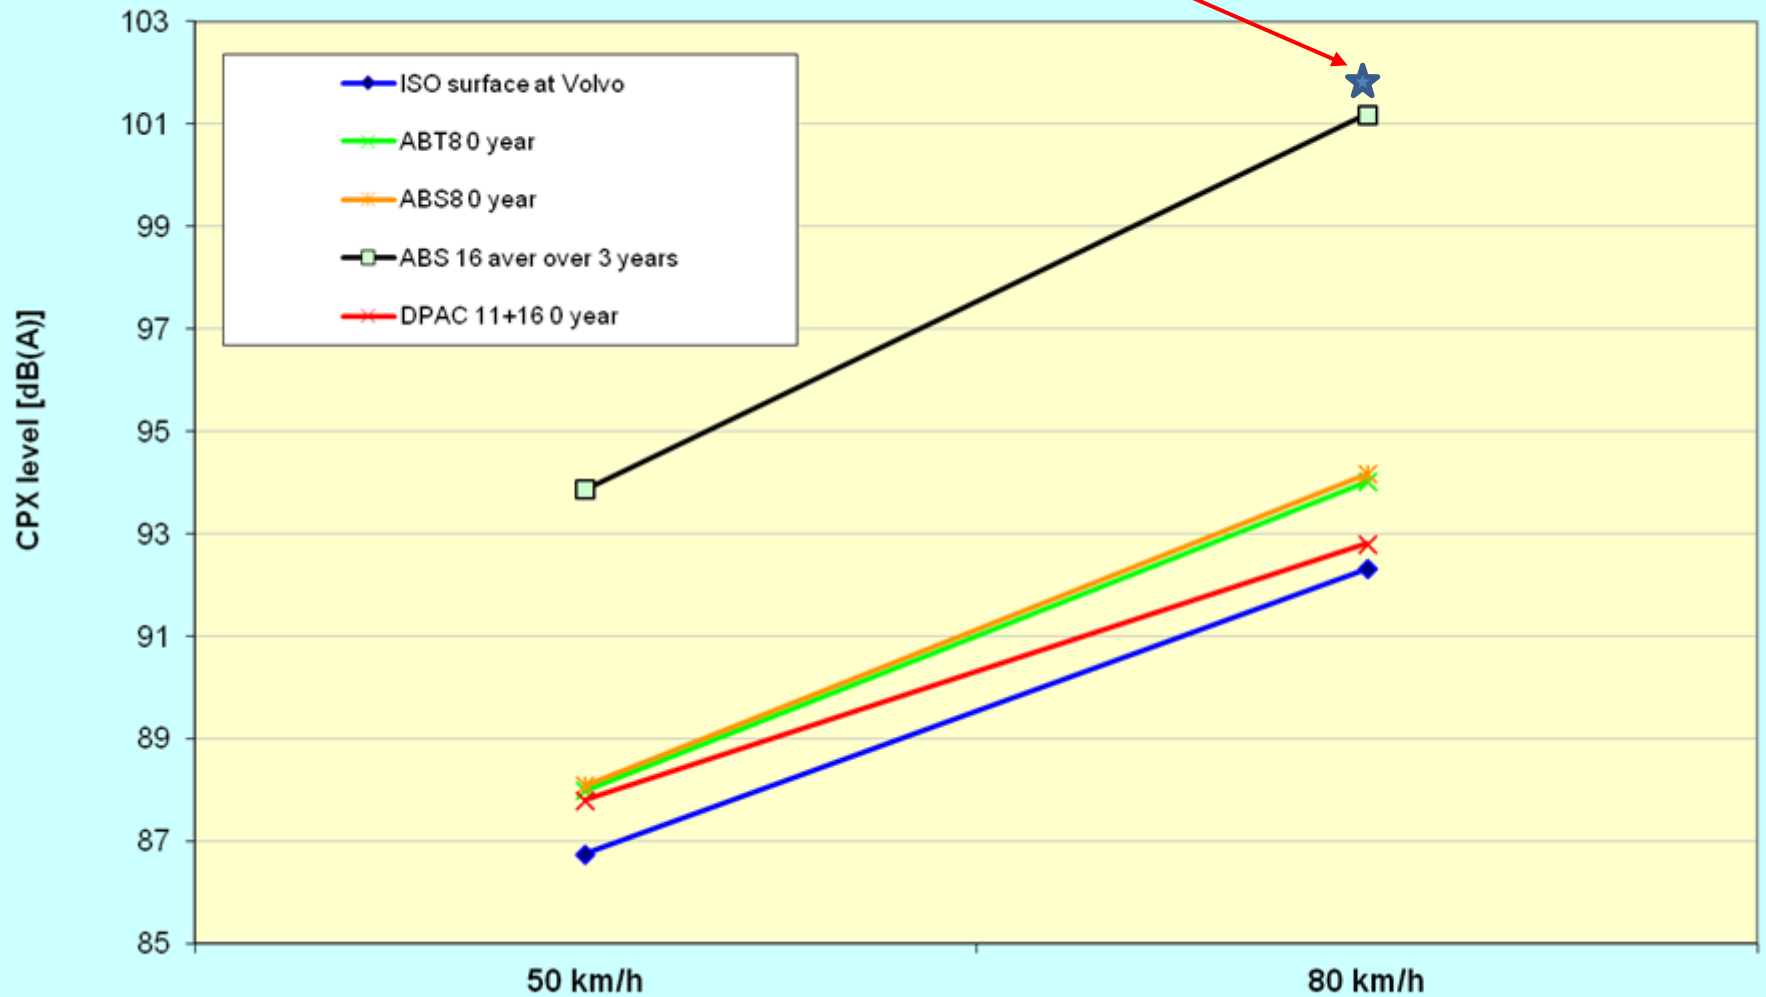
# Slipad cementbetong (E4 Uppsala) belägenhet jfrt med några andra beläggningar - Tyre P1

Comparison of Volvo ISO track with real road surfaces - SRTT

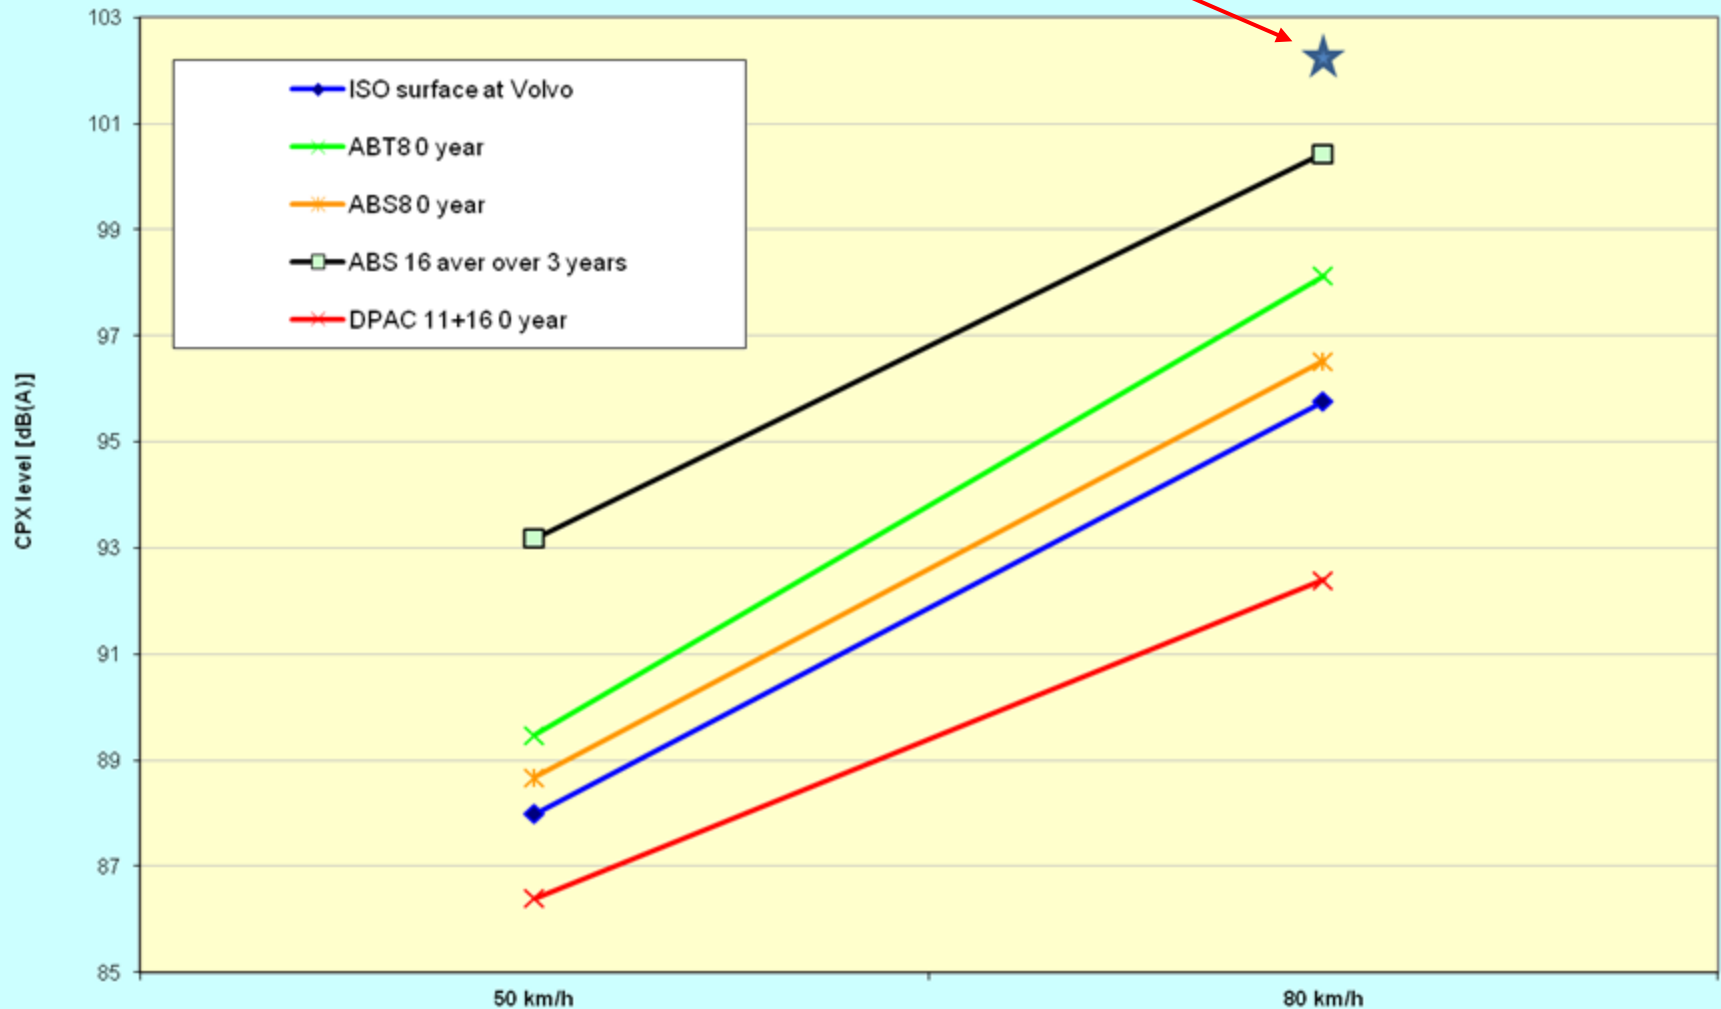
# Slipad cementbetong (E4 Uppsala) belägenhet jfrt med några andra beläggningar - Tyre H1

Comparison of Volvo ISO track with real road surfaces - AAV4

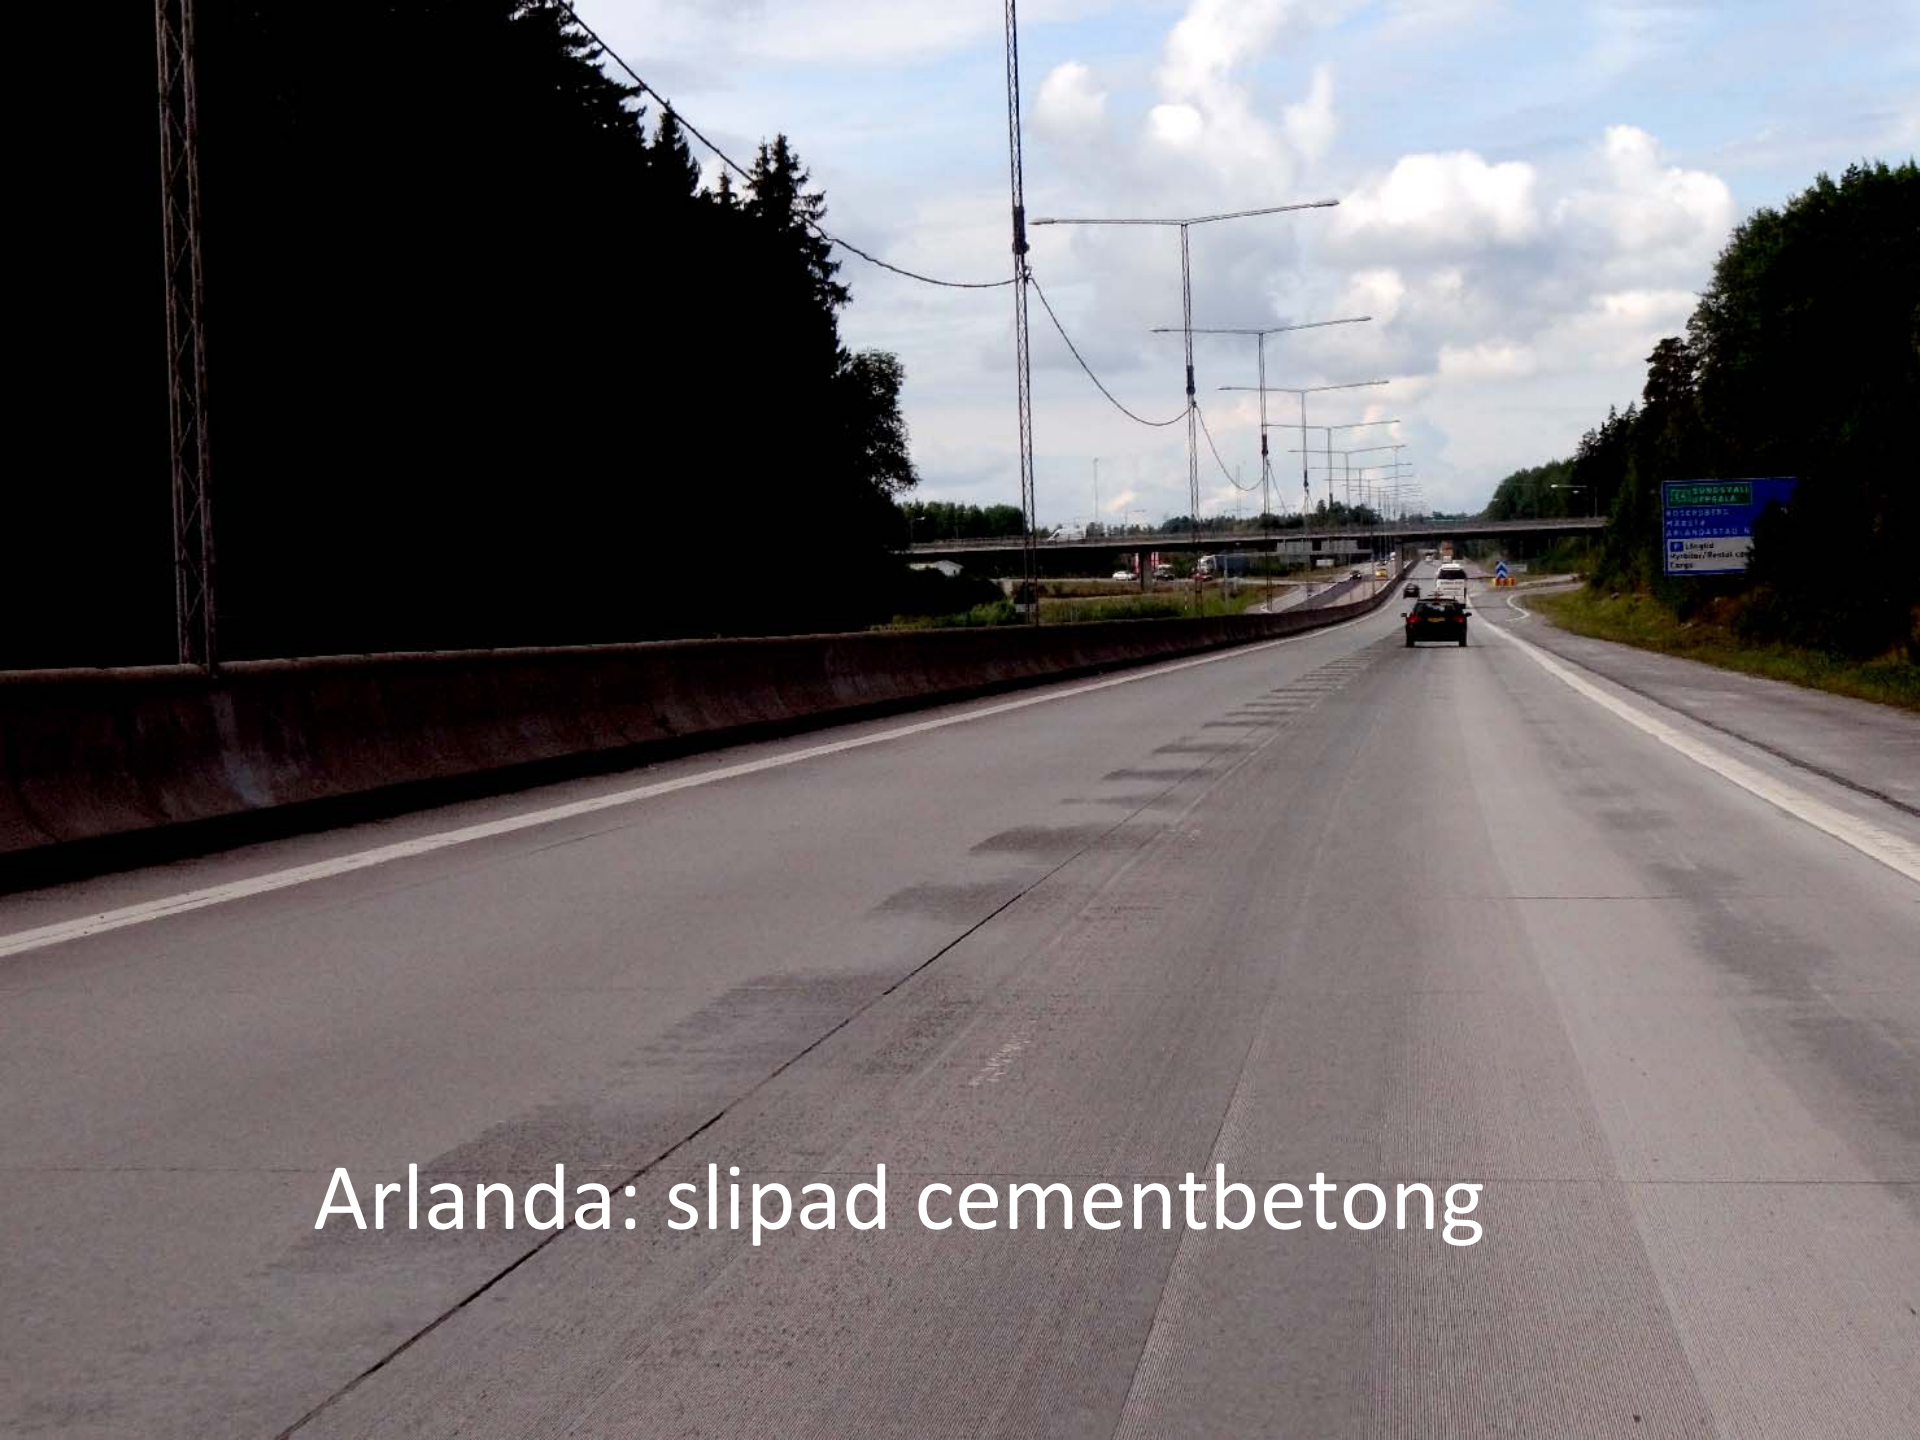
Arlanda: slipad cementbetong

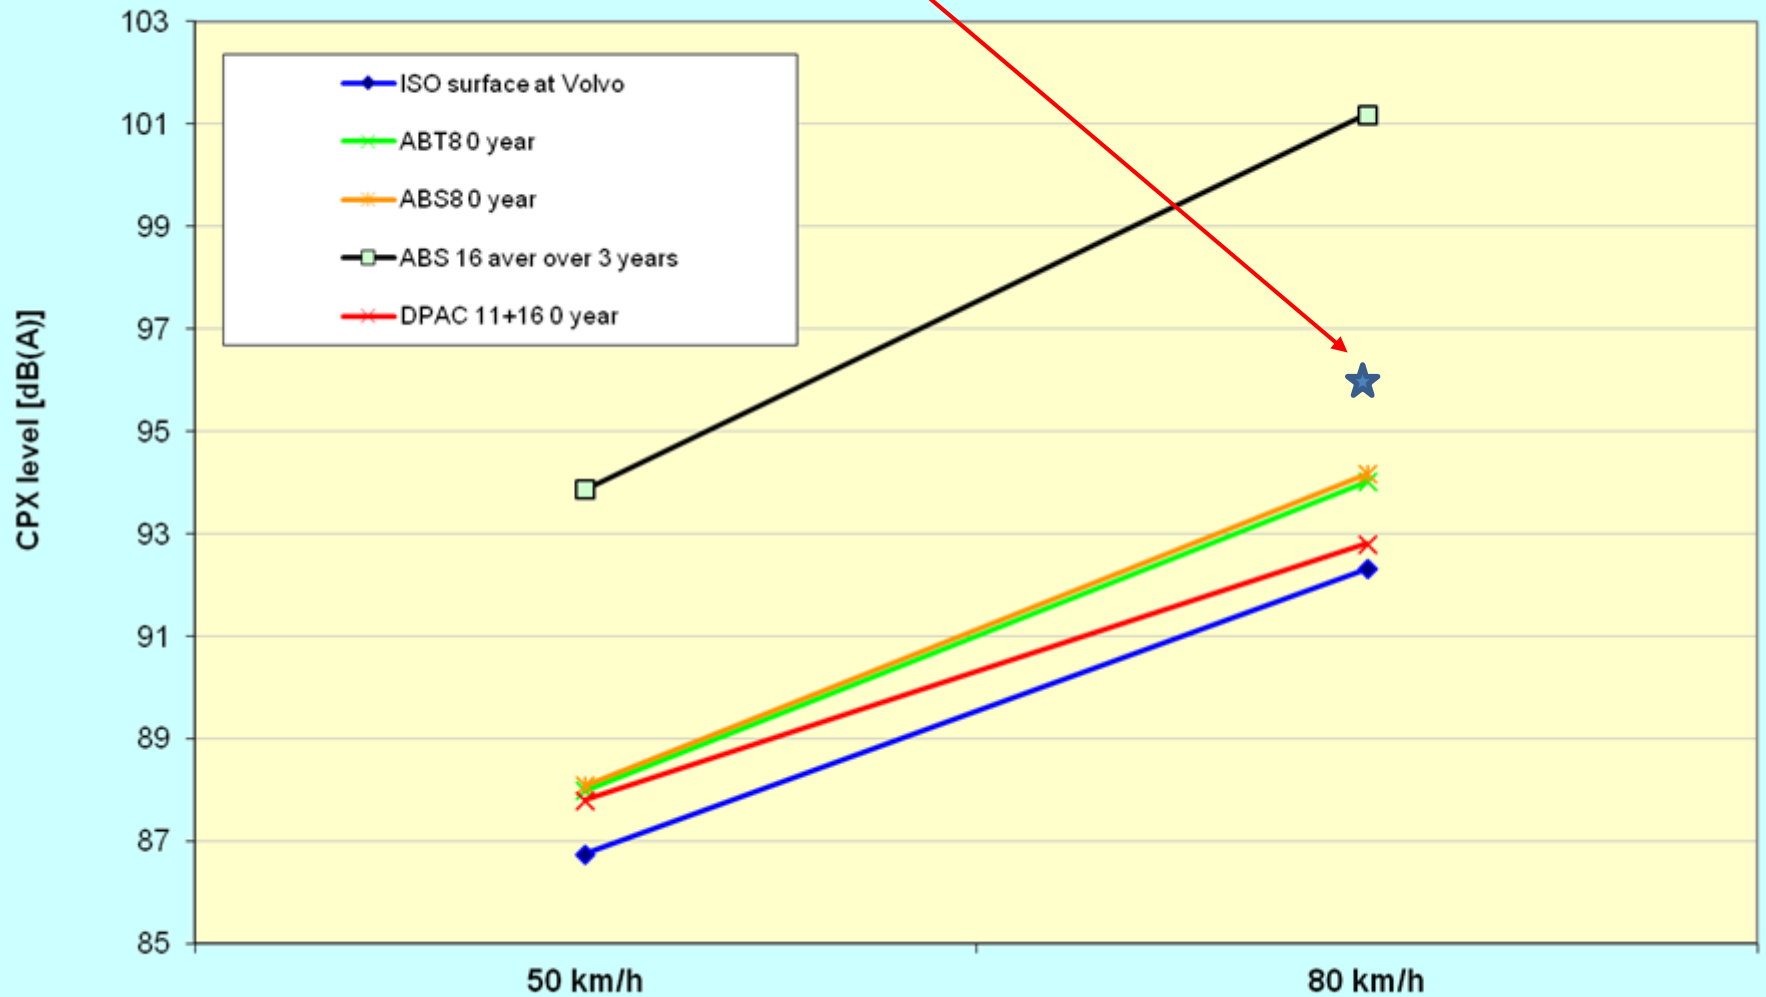
# Slipad cementbetong (Arlanda) belägenhet jfrt med några andra beläggningar - Tyre P1

Comparison of Volvo ISO track with real road surfaces - SRTT

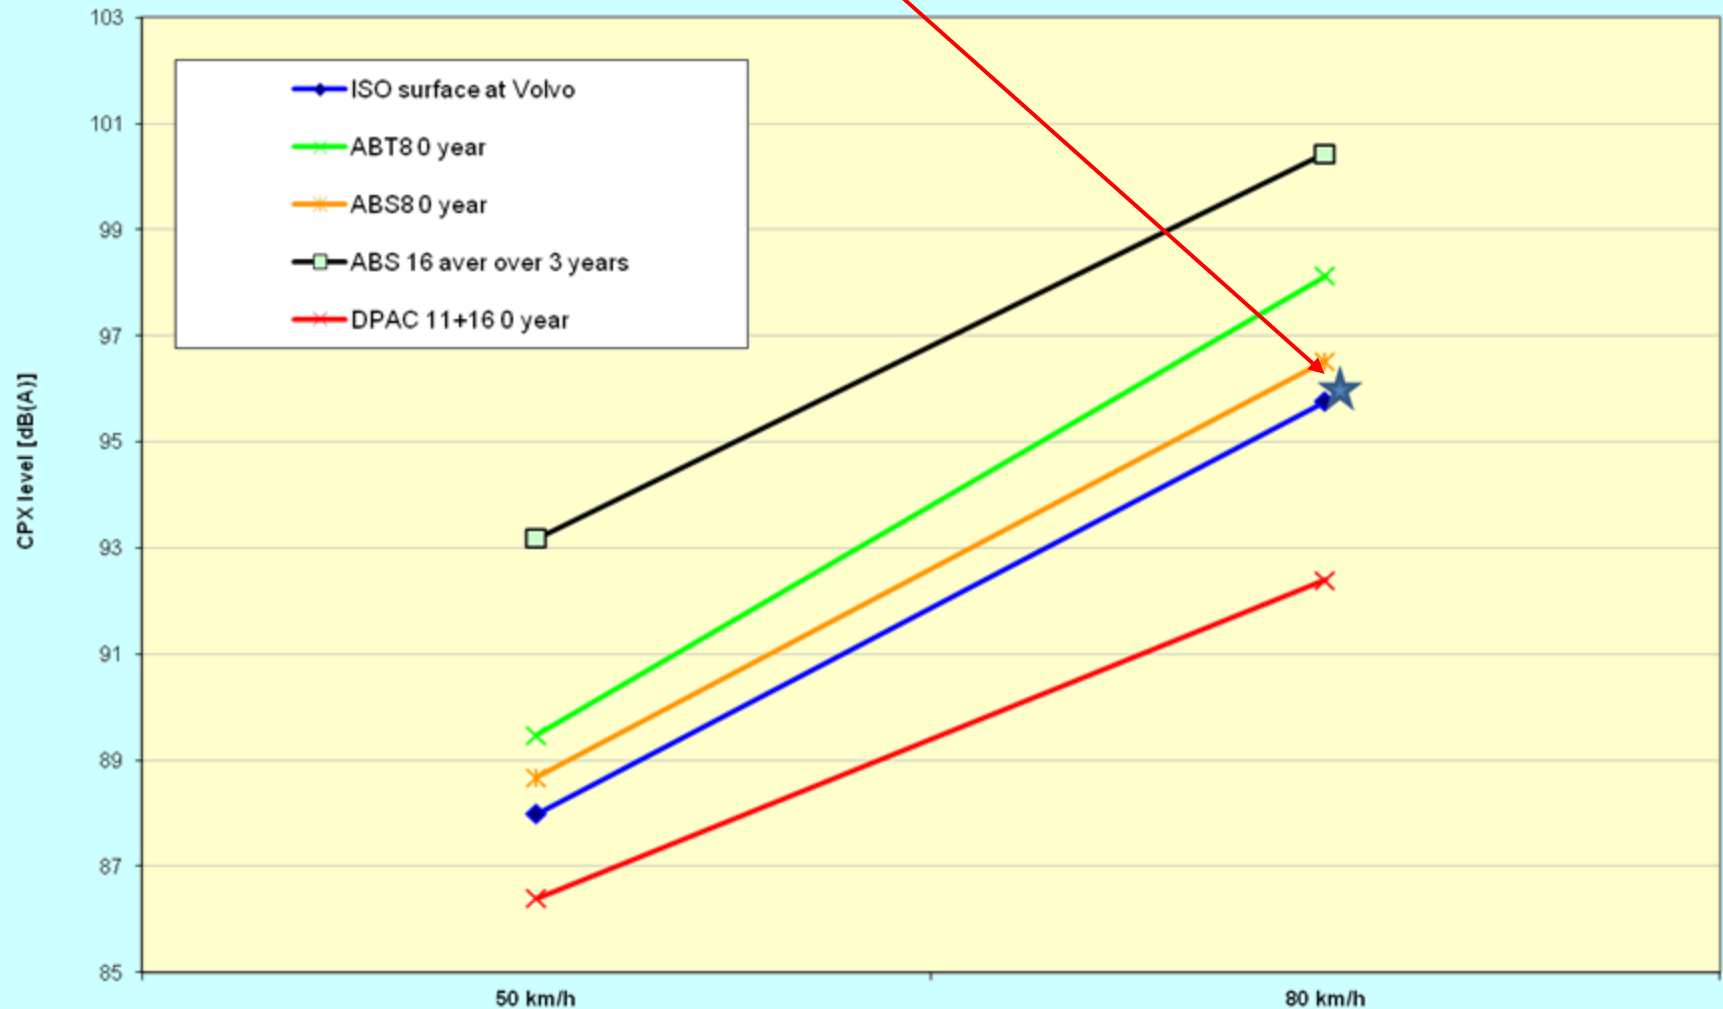
# Slipad cementbetong (Arlanda) belägenhet jfrt med några andra beläggningar - Tyre H1

Comparison of Volvo ISO track with real road surfaces - AAV4

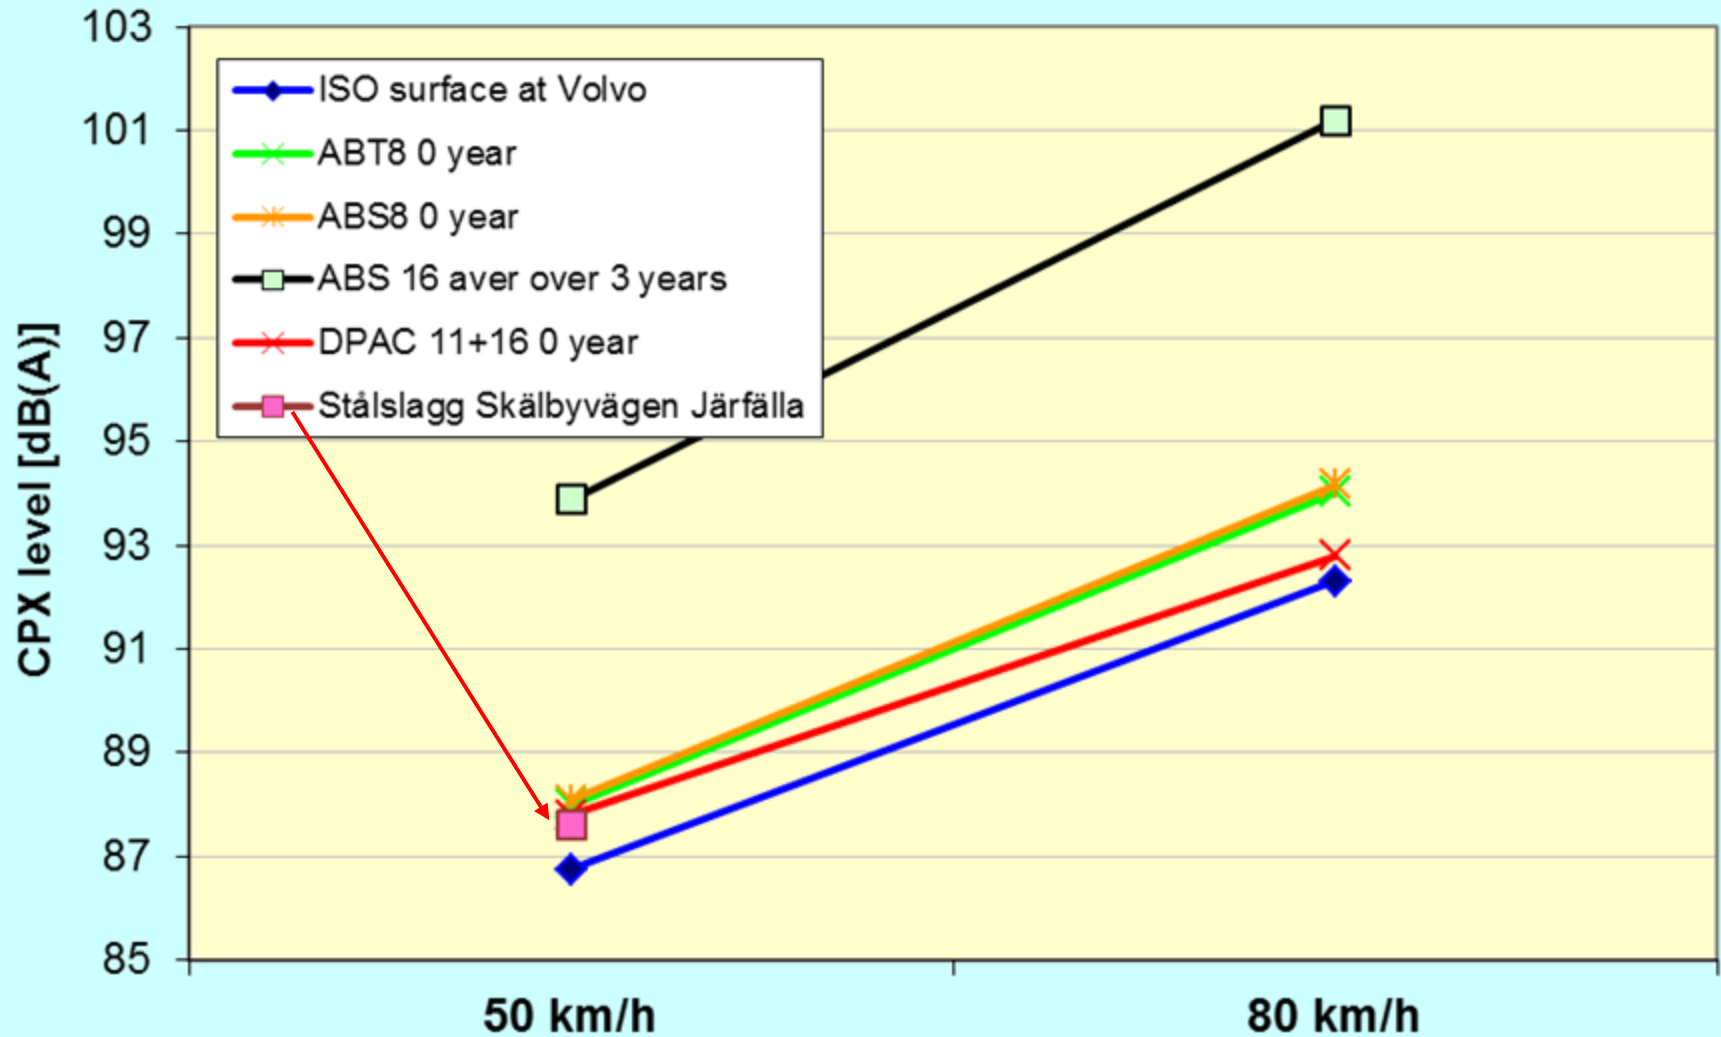
# Stålslaggens belägenhet jfrt med några andra beläggningar

## Tyre P1

Comparison of Volvo ISO track with real road surfaces - SRTT
