# Texturoptimerade vägbeläggningar

**Av Ulf Sandberg**

**VTI**

TRV Seminarium i Solna 2012-12-12

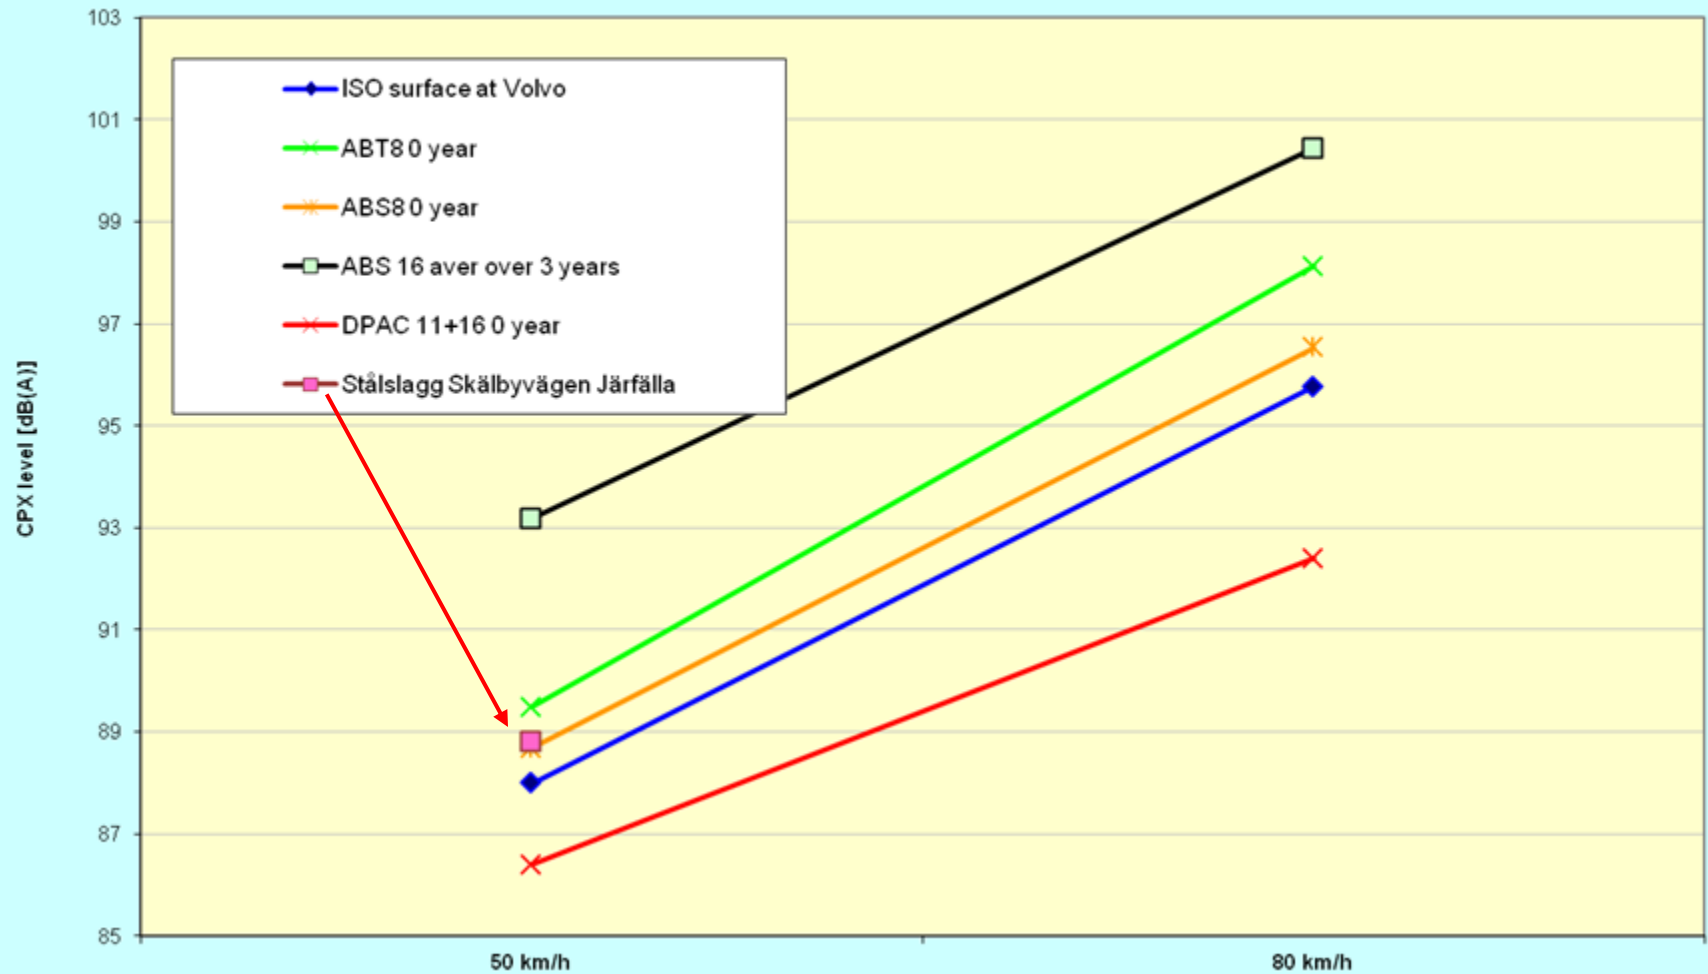
# Stålslaggens belägenhet jfrt med några andra beläggningar

## Tyre H1

Comparison of Volvo ISO track with real road surfaces - AAV4
